*Visual Inspection Report*

# STRUCTURAL REVIEW OF BRIDGE over BIG WALNUT CREEK

VILLAGE OF SUNBURY  
DELAWARE COUNTY, OHIO

Date of Inspection: December 11, 2018

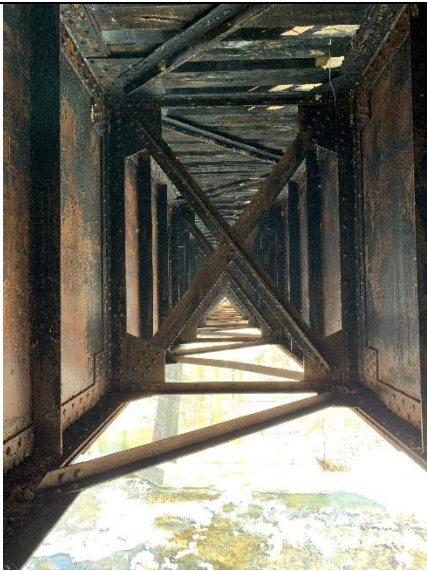
Photo 1

**Lateral Bracing** - The bracings are in fair condition with minor section losses (Photo 1).

1. Sandblast and clean the entire steel superstructure
2. Fix Rear Abutment scour and foundation undermining problem (correct erosion problem by incorporating scour countermeasures to prevent further degradation)
3. Repair and patch spalled bridge seat at all substructure units (abutment and piers) and seal repaired surfaces with epoxy-urethane Sealer
4. Clean and refurbish all bearings
5. Address and fix embankment problem for a new approach pavement at forward abutment area

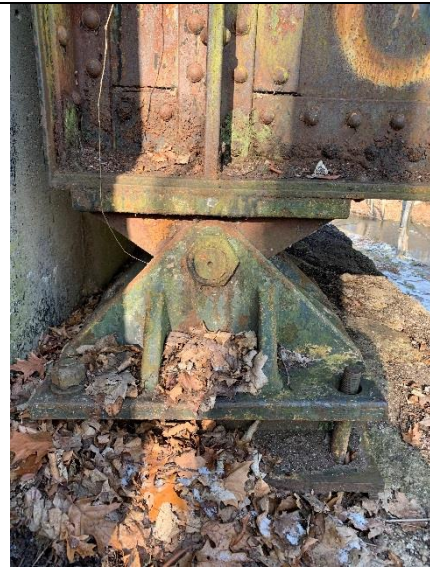
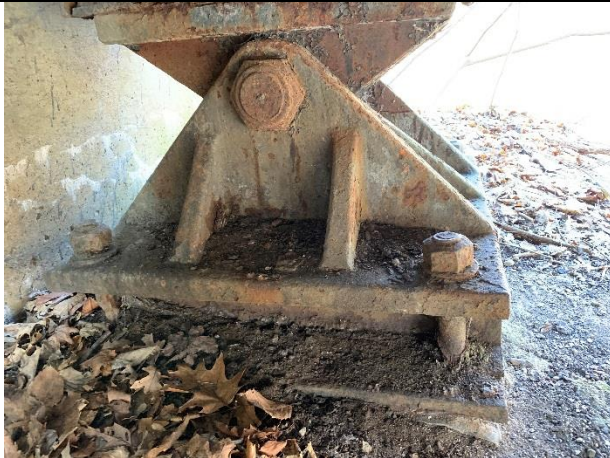
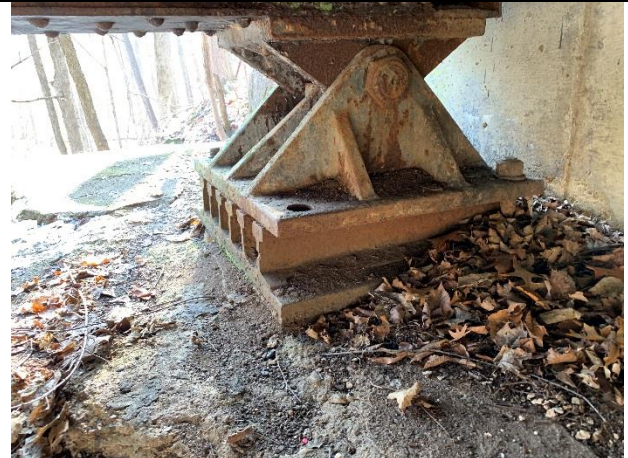
**Bearing Devices** - Spans 1 and 2 are supported on a steel rocker 'Roller Nest' expansion type bearings on each girder end while girders in span 3 are supported on a 'stilt-framed' fixed type bearing on pier 2 and a 'sliding plate' type expansion bearings at the forward abutment. In general, all bearings in spans 1 and 2 are in poor condition as they exhibit missing nuts with their nests frozen and locked in place due to heavy rust pack and are not functioning as designed (Photo 2-4).

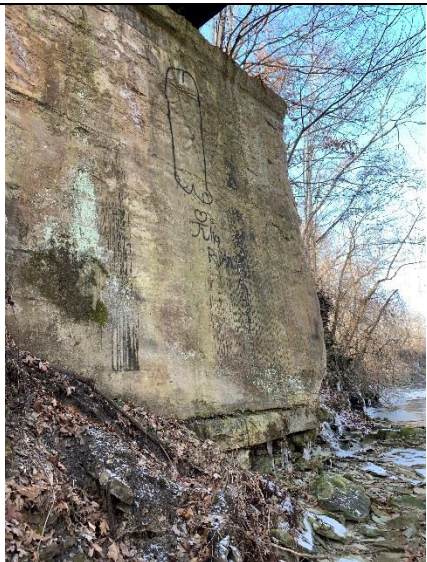
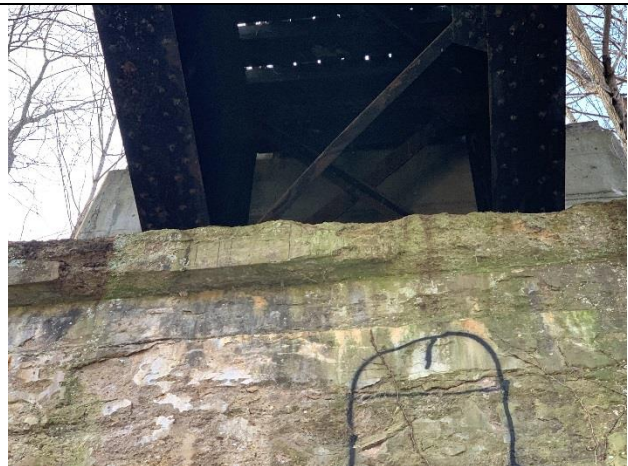
**Abutments** - The Rear Abutment is in poor condition with heavy spalled areas, concrete delamination behind the abutment (Photo 5 and 6). Scour was observed due to the eroding action of Big Walnut Creek and it is continuous. Undermining of the abutment foundation is imminent as the weathered shale support is eroding away below and behind the abutment (Photo 7 thru 9).

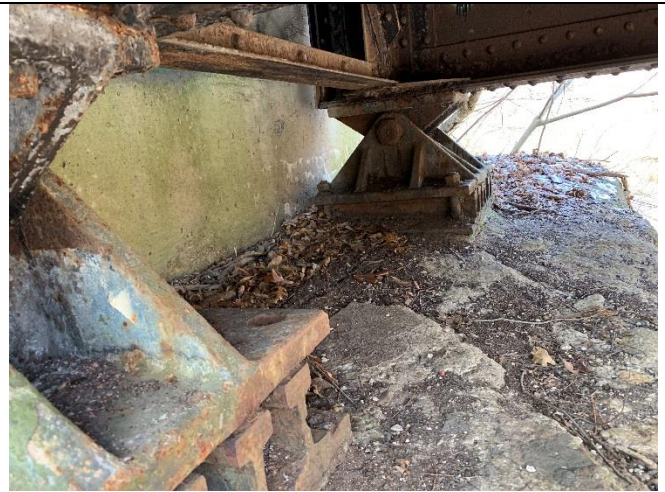
Photo 10

**Abutment Seats** - The seat area of the Rear Abutment is in fair condition (Photo 10). Debris consisting of sand and steel rust residue can be found surrounding the bearings above the bridge seat. Cleaning of bridge seat area at this abutment is highly recommended.

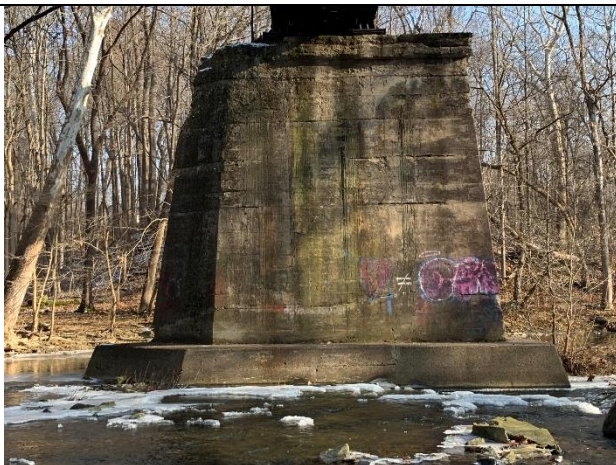
Photo 11

**Piers & Pier Seats** - Cracks and spalling areas were observed at the piers seats (Photo 11). The seat areas at piers are in fair condition. Debris consisting of sand and steel rust residue can be found surrounding the bearings above the seat. Cleaning of bridge seat area at this abutment is highly recommended (Photo 12).

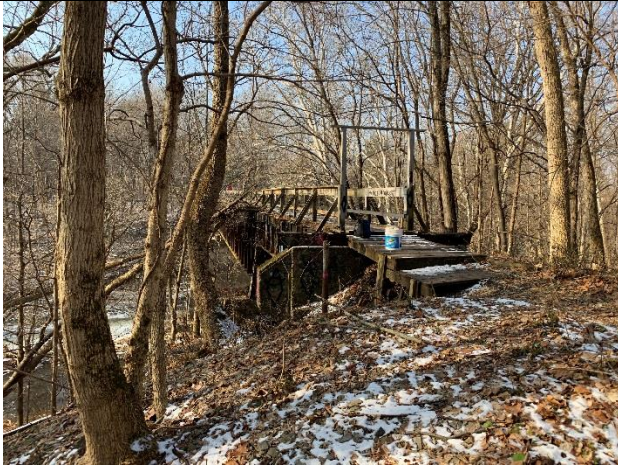
Photo 13

**Wingwall** – The back of the wingwalls of the Forward Abutment are exposed and embankment and fillings that were supposed to retain the approach pavement have been displaced (Photo 13).

This is in “Poor Condition” because the embankment and support materials that were supposed to retain the forward approach pavement have been displaced and spilled down the slope.

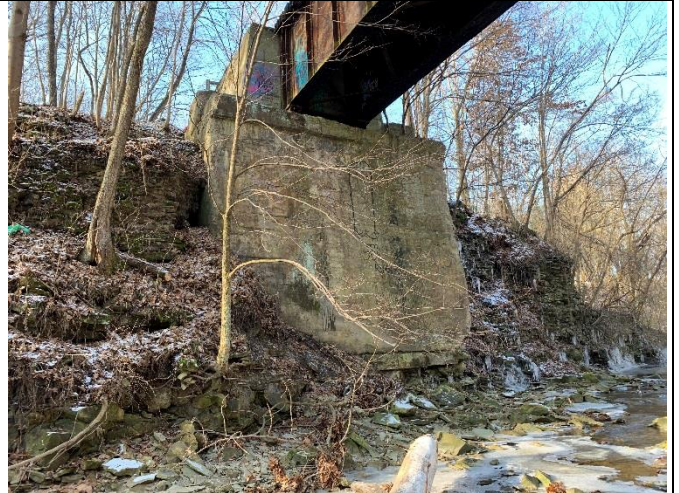
Photo 14

The channel of the Big Walnut Creek under the structure is given a “Fair Condition” rating. Items noted were channel alignment, slope erosion and scour at the Rear Abutment. A corrective action is recommended at the abutment (Photo 14).
