*Visual Inspection Report*

# STRUCTURAL REVIEW OF BRIDGE over BIG WALNUT CREEK

VILLAGE OF SUNBURY  
DELAWARE COUNTY, OHIO

Date of Inspection: December 11, 2018

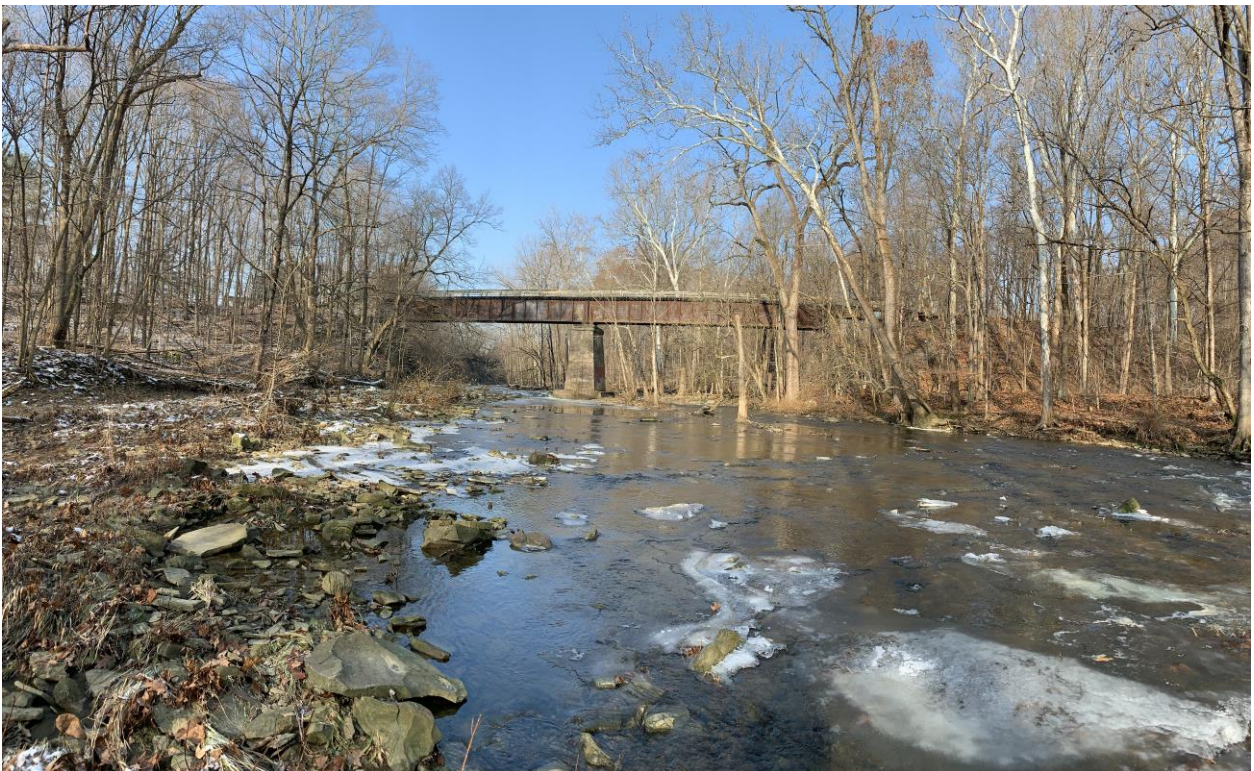
South Elevation of Bridge

The substructures (abutments and piers) consist of a full-height Rear Abutment, a stub-type Forward Abutment and two solid-shaft Piers. The maximum height measured from the top of deck to the channel flow-line of Big Walnut Creek is approximately 45 feet.
